What's Gone Wrong

A brief overview of coating issues encountered
in the emerging site-applied UV market

Daniel Dayon
HID Ultraviolet
RadTech 2012

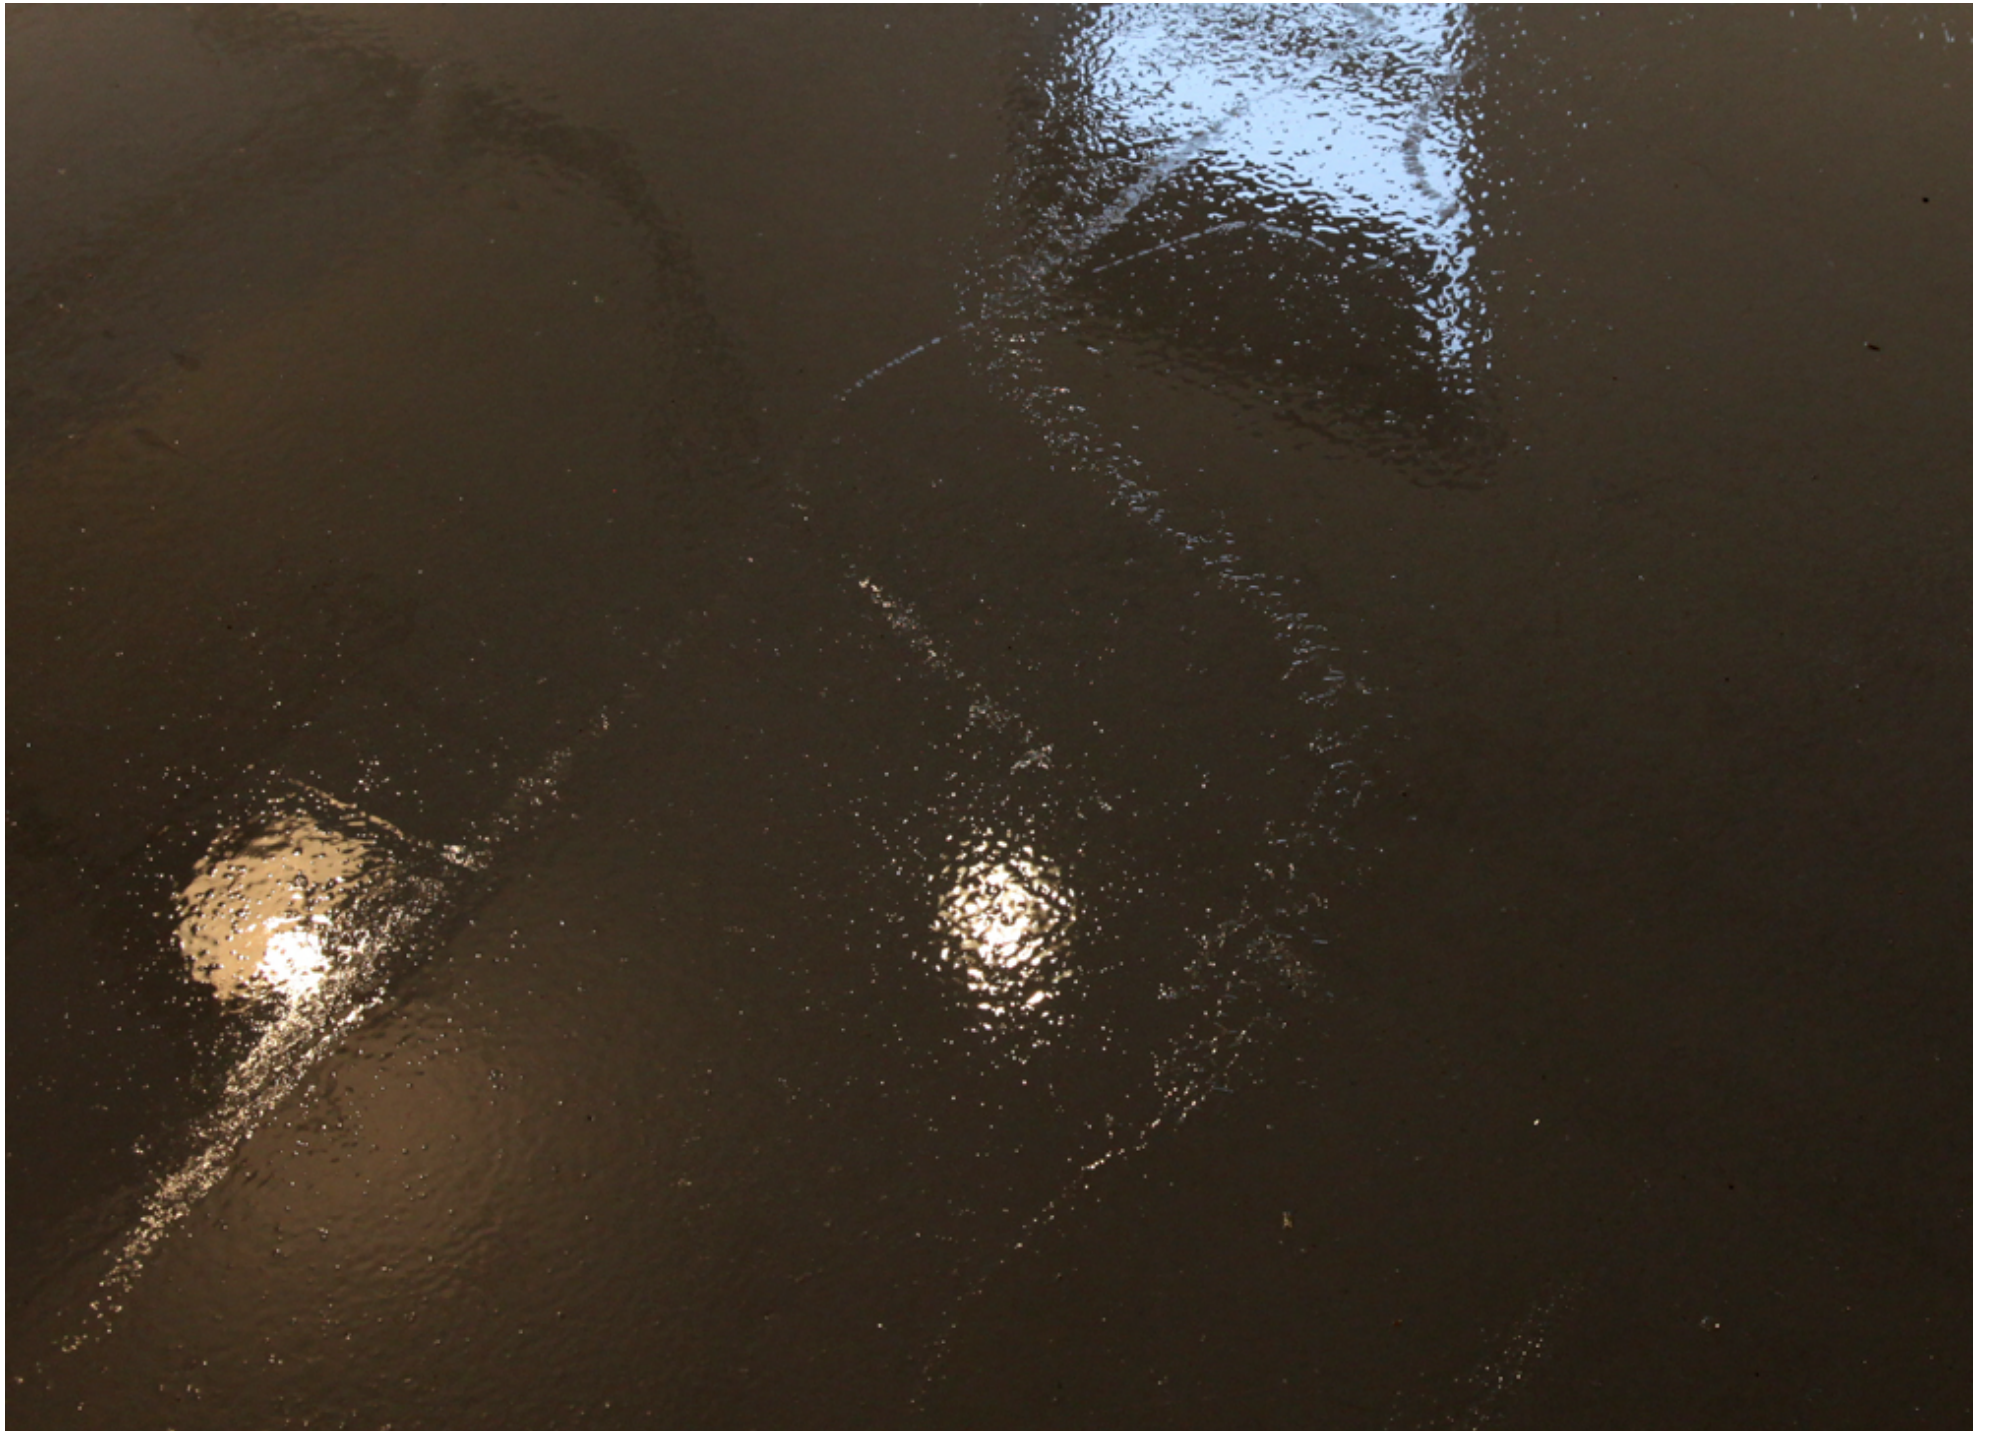
Zipper Lines.....

- In the factory, cure widths are bigger than your substrate.
- 10 foot lamp? No problem!
- On the job site? Problem....
- Curing wider than about 2.5' is unfeasible due to doors, maneuvering, uneven floors, etc.
- This leads to the much maligned zipper line.

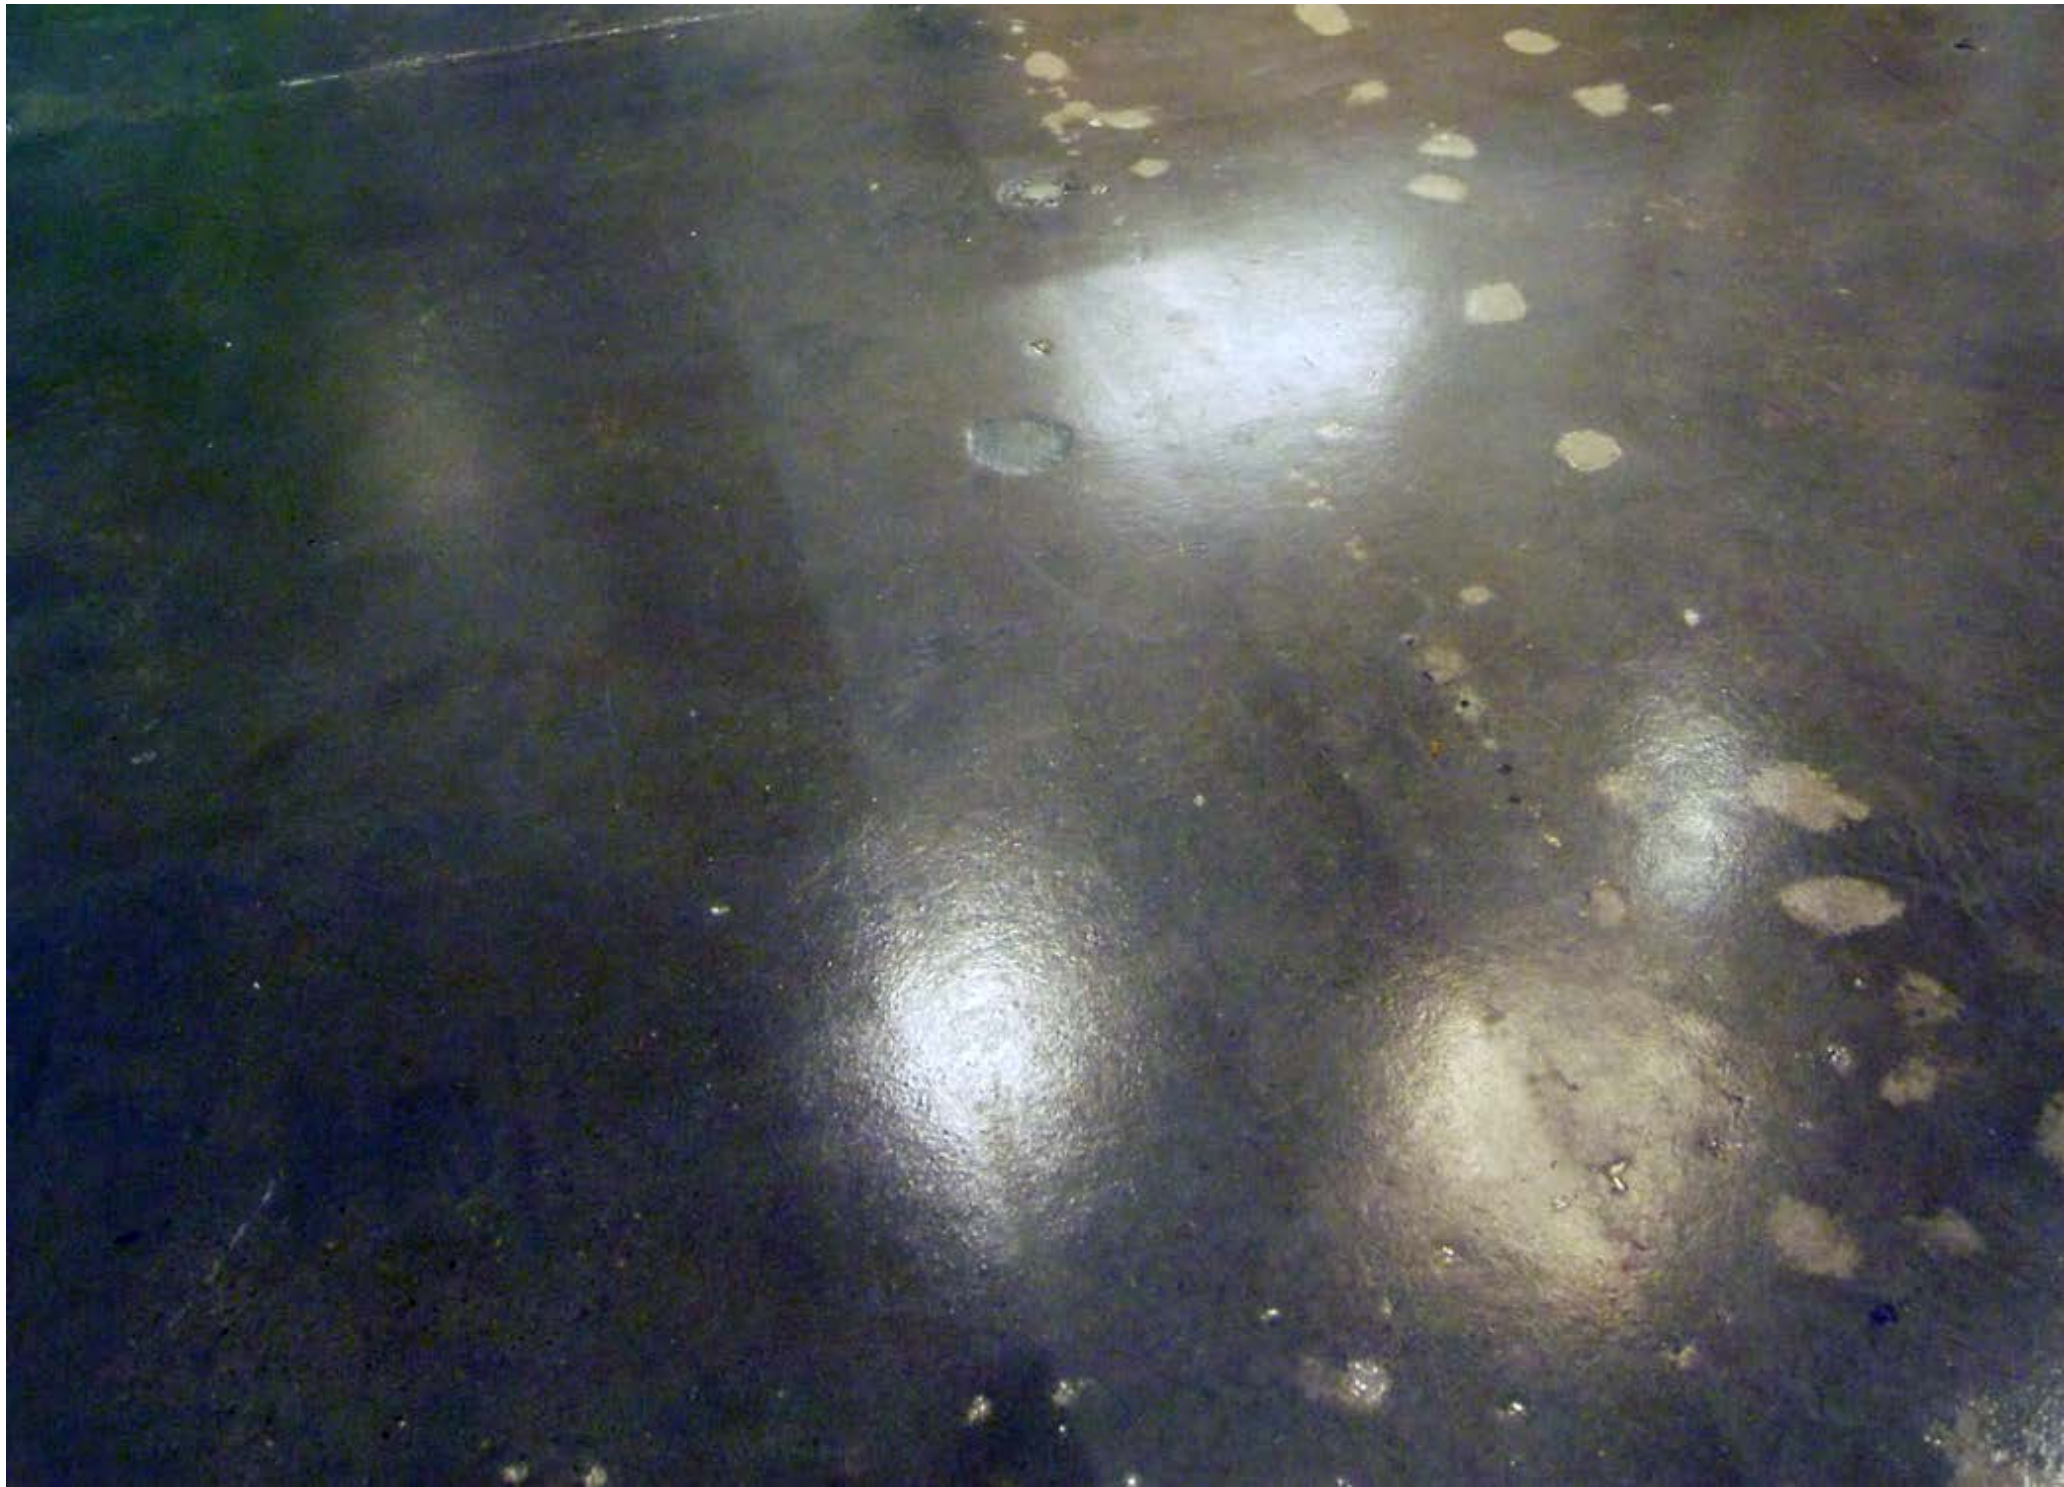
Can we fix it with optics?

- Feathering light out can sometimes reduce or eliminate zippers by giving a cure gradient away from the machine, softening the shrinkage differential.
- However....
 - Partial curing tends to introduce differences in finish appearance: gloss lines/haziness/etc. This is **far** more pronounced when the coating contains matting agents.
 - A potentially unsafe piece of equipment in untrained hands is now a very dangerous piece of equipment in all hands.

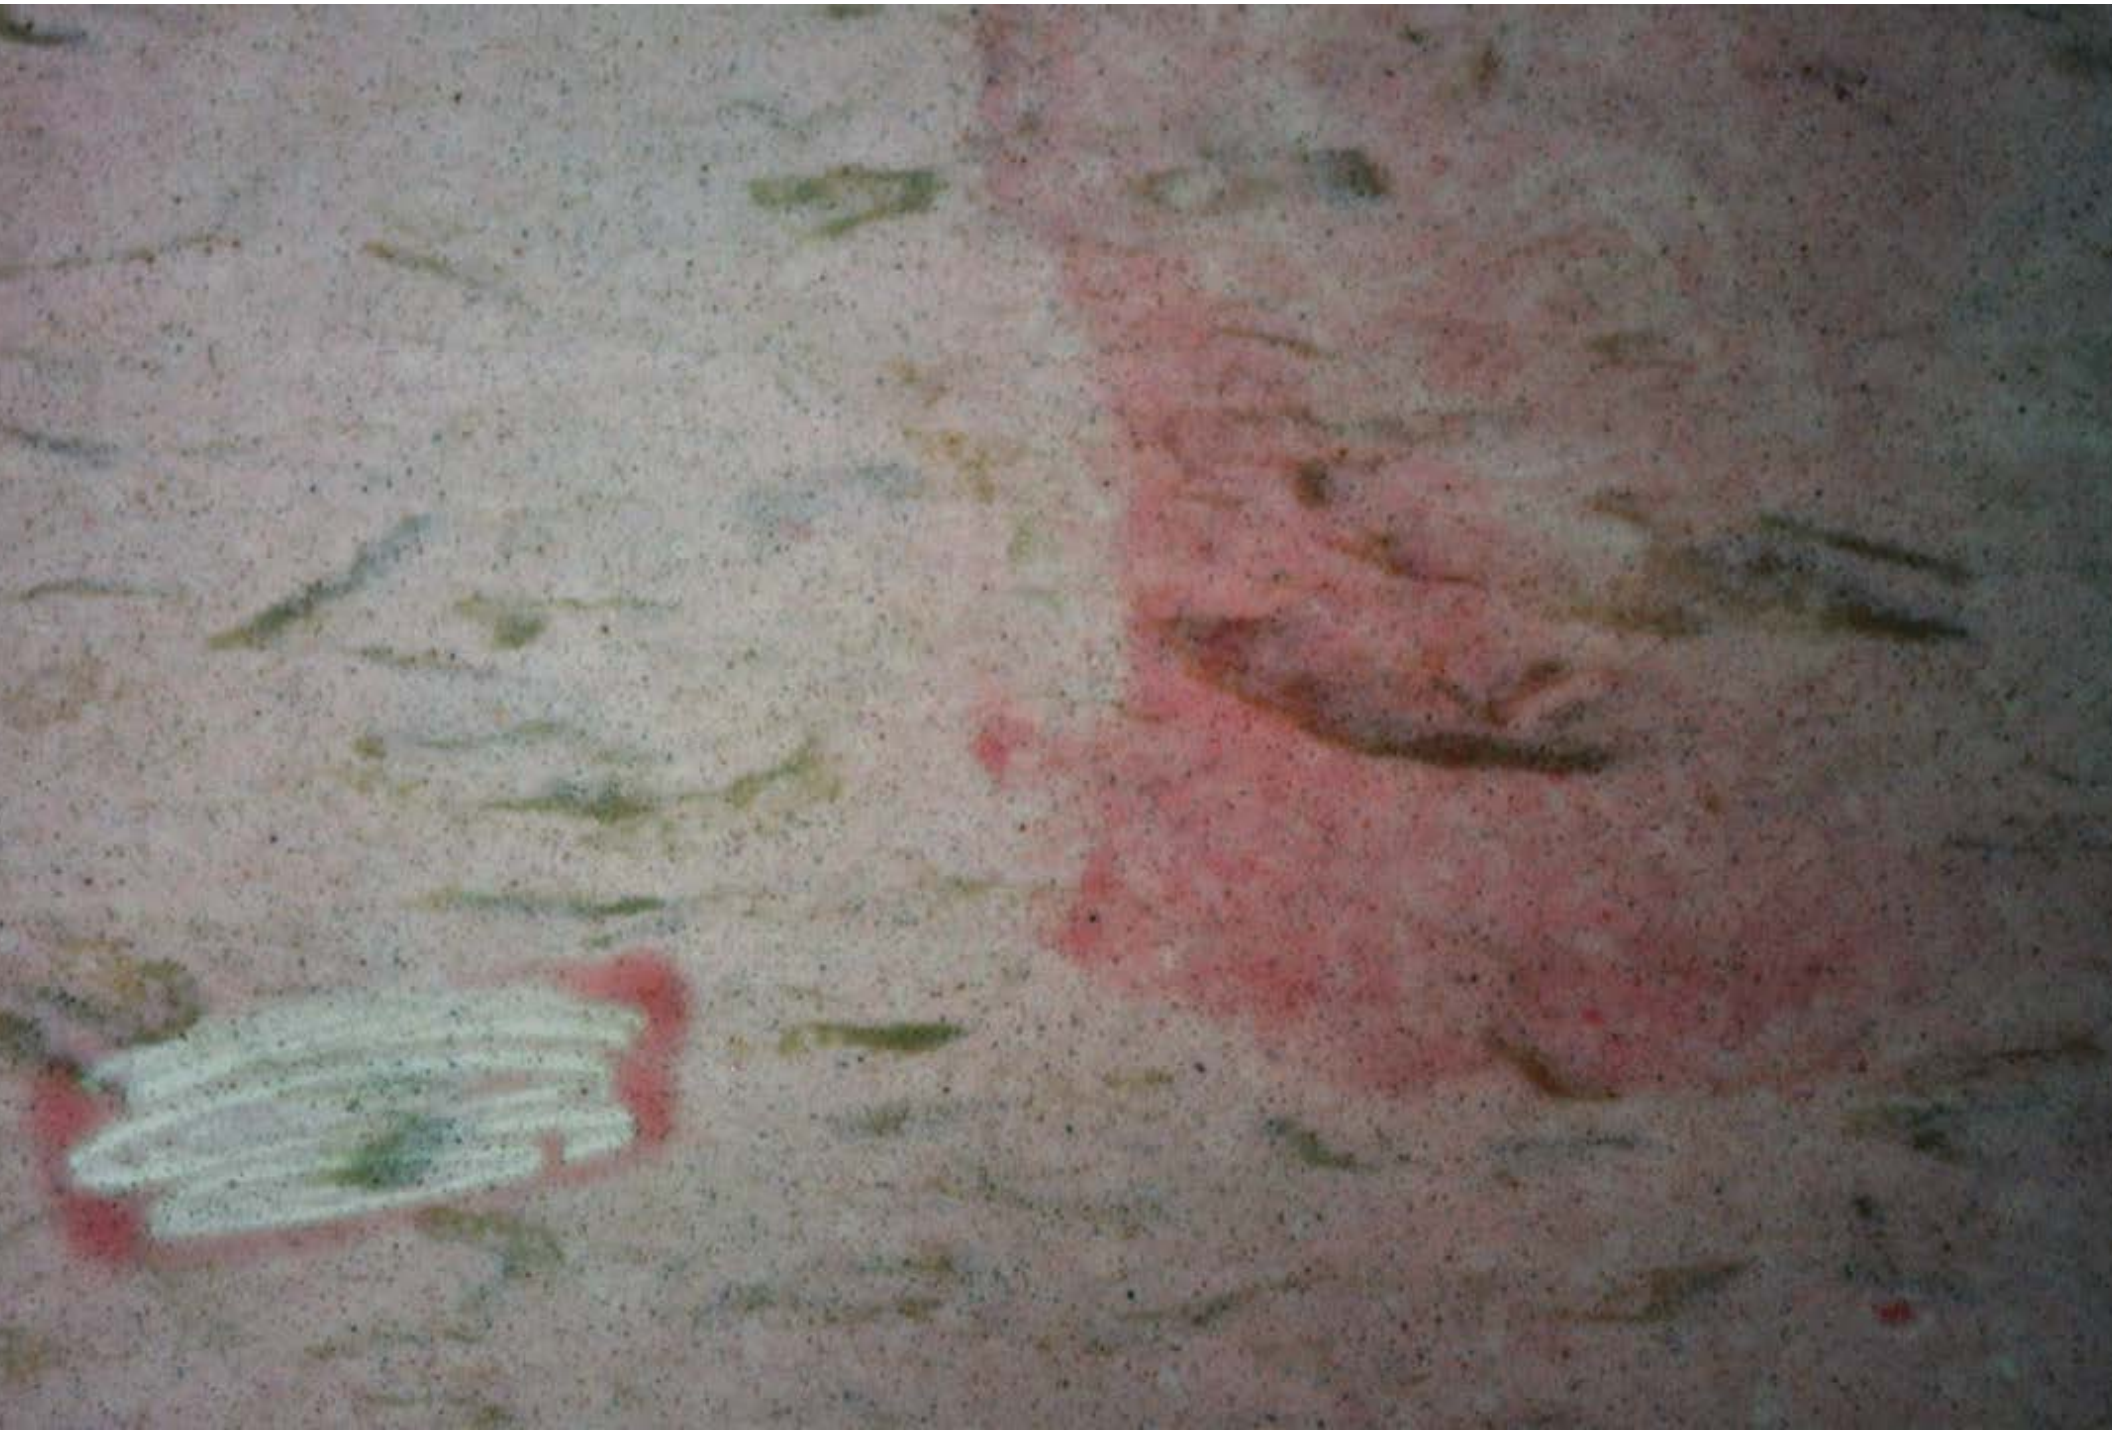
How thick?

- Make sure applicators are trained with wet film thickness gauges. Many don't know how to use them! (And many have an epoxy-based mindset of 'more is better')
- Bleaching dyes allow for applicators to spot at a glance an area that is too thin or too thick.
- The usefulness of such dyes in this regard cannot be overstated.
- One puddle = blister/crack/spiderweb = costly repair
