UV or Not to UV—A Small American Manufacturer Takes a Technological Leap

By Doug Hatch

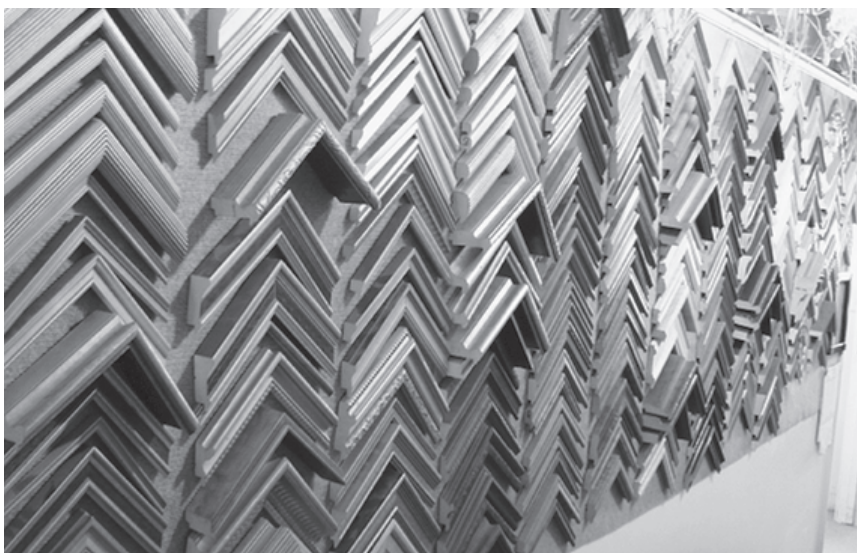
PB&H Moulding makes decorative moulding with UV coatings.

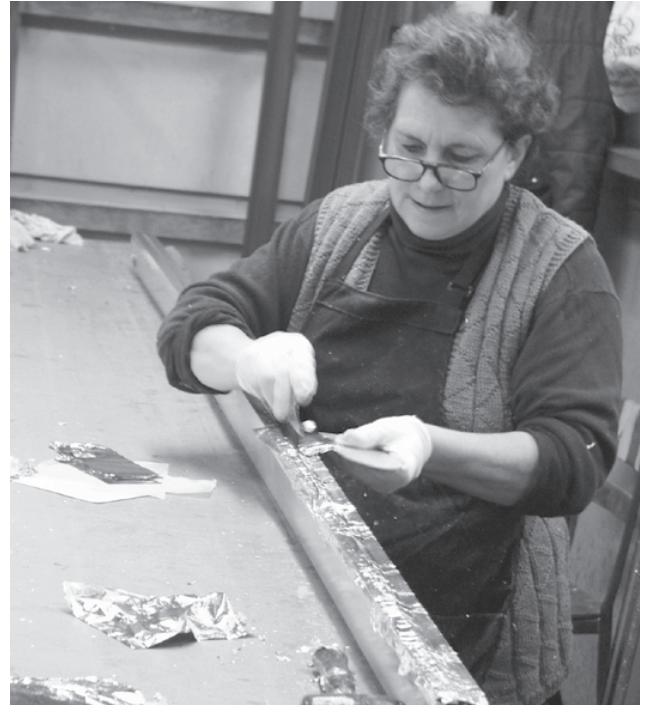
PB&H specializes in hand finishing, but a UV clearcoat was an excellent solution to a big bottleneck.
